# Manhole Inspection Summary

Manhole # S45KK\_020MH

Insp Date: **4/16/08 10:14 AM**

**Location** Address: **E Lanvale St**

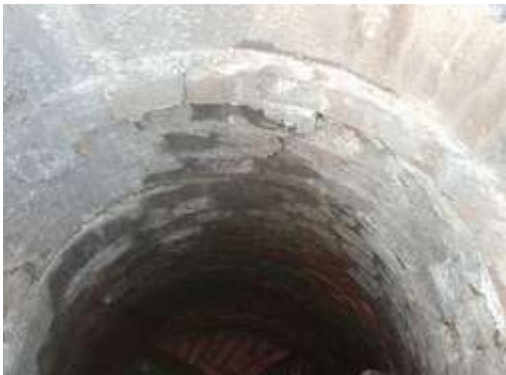
Defect 1

Infiltration: ☐ None ☒ **Joint** ☐ Cracks ☒ **Mortar** ☐ Roots ☐ Wall

Infiltration

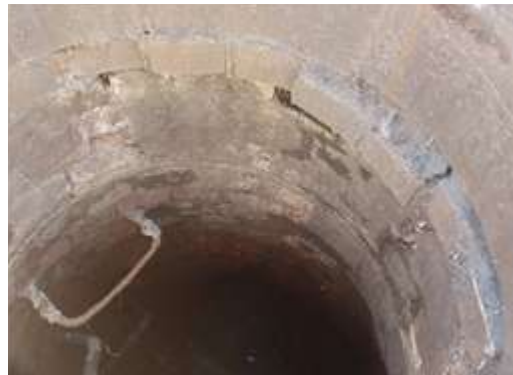
Defect 2

Condition: ☐ Sound ☐ Cracked ☐ Root Intrusion ☐ Loose Brick ☒ **Deteriorated**

Loose Bricks

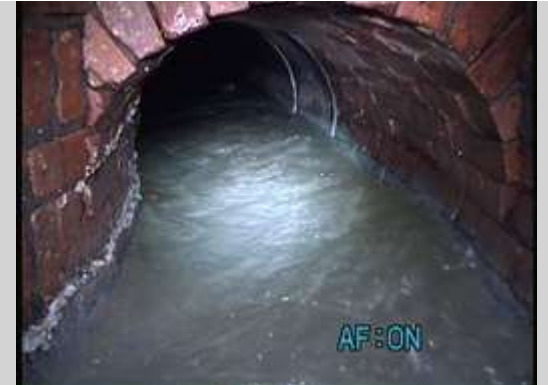
12 O'Clock Outflow

22 in. Circular Gravity Sewer  
Pipe Out @ 12 O'Clock

Pipe Height: **21.6** (in.) Rod and Bar (Angled)  
Pipe Material: **Clay** ☐ Pipe Lined  
Invert Depth: **10.80** (ft.) Flow Characteristics: **Fast**  
Deposits: ☒ None ☐ Mud ☐ Sludge ☐ Debris ☐ Grease  
Silt Depth: (in.) Deposits Extent:  
Infiltration: **None** Pipe Seal Cond: **Sound**

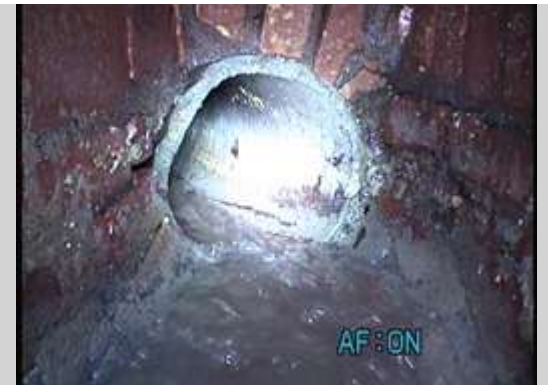
4 O'Clock Inflow

8 in. Circular Gravity Sewer  
Pipe In @ 4 O'Clock

Pipe Height: **8.4** (in.) Rod and Bar (Angled)  
Pipe Material: **Clay** ☐ Pipe Lined  
Invert Depth: **10.10** (ft.) Flow Characteristics: **Fast**  
Deposits: ☒ None ☐ Mud ☐ Sludge ☐ Debris ☐ Grease  
Silt Depth: (in.) Deposits Extent:  
Infiltration: **None** Pipe Seal Cond: **Sound**

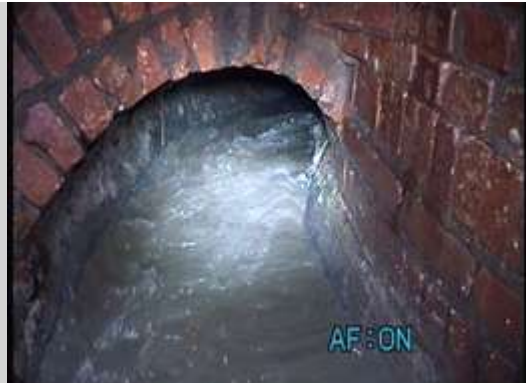
7 O'Clock Inflow

22 in. Circular Gravity Sewer

Pipe In @ 7 O'Clock

Infiltration: **None** Pipe Seal Cond: **Sound**
